NOTICE ABOUT ARTCAM ON Core i SERIES CHIPSET

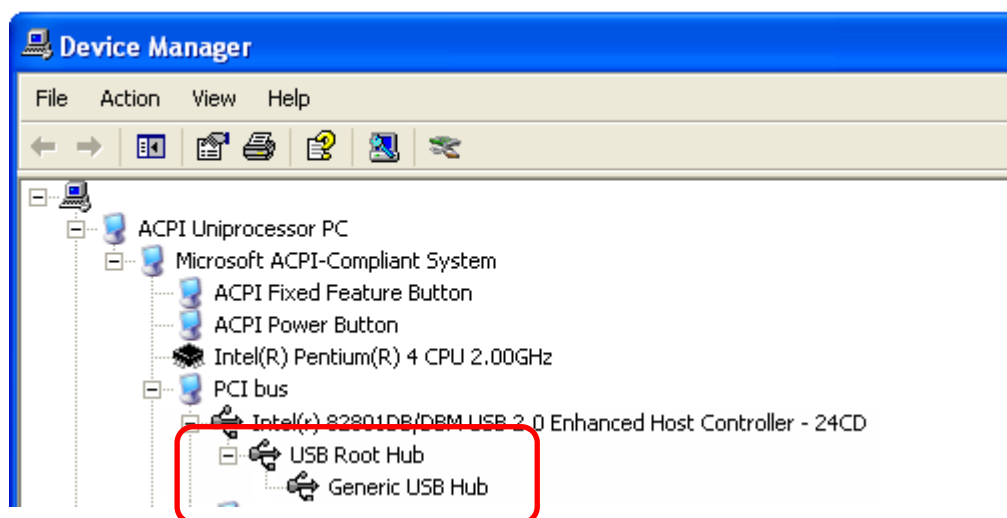
③Follow the order below to find out what device is under USB Root Hub.
[ACPI ··· PC] → [Microsoft ACPI-Compliant System] → [PCI Bus] →
[···USB Enhanced Host Controller] → [USB Root Hub]

If [Generic USB Hub] is right under [USB Root Hub], you may encounter this problem.

CCD Camera : Our engineer can adjust the Operation Clock to half speed, and then the camera will be able to function properly. However the frame rate will become half, too.

CMOS Camera : The Operation Clock can be adjusted to half speed either by our engineer or by the customer via the Viewer Software, and then the camera will be able to function properly. However the frame rate will become half, too.
